## Streambank Mapping Driftwood River to Identify Areas of Erodibility

Kelsey Hensley  
Biosystems Engineering, M.S. Student  
Biosystems Engineering and Soil Science

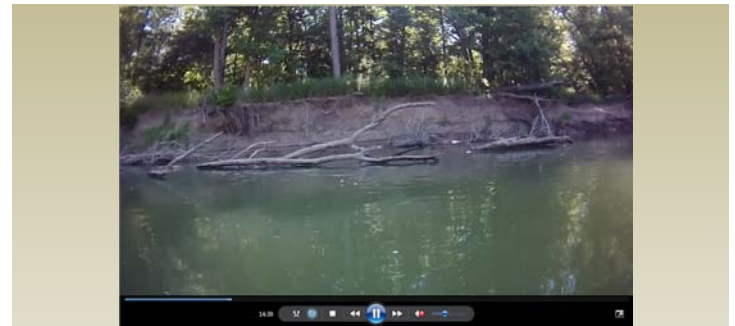
Bank Angle = 6.95, Bank Height = 7.5, Surface Protection = 9, Riparian Diversity = 9

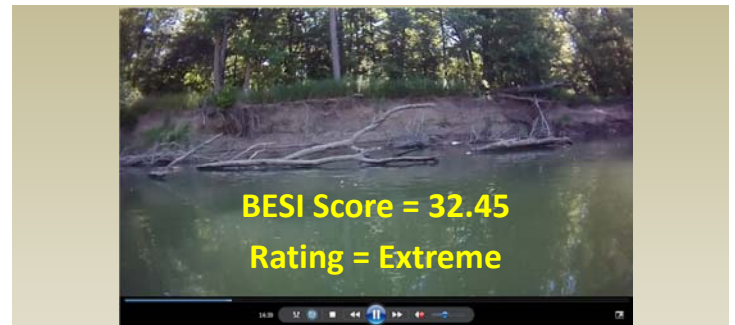
Bank Angle = 6.95, Bank Height = 7.5, Surface Protection = 9, Riparian Diversity = 9

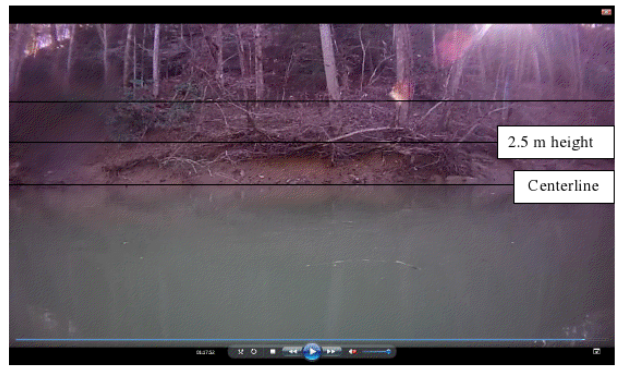
Figure 1: Photo from New River (TN) showing:

Bank Angle = 9, Bank Height = 7.5 ft, Surface Protection = 6.95, Riparian Diversity = 6.95.

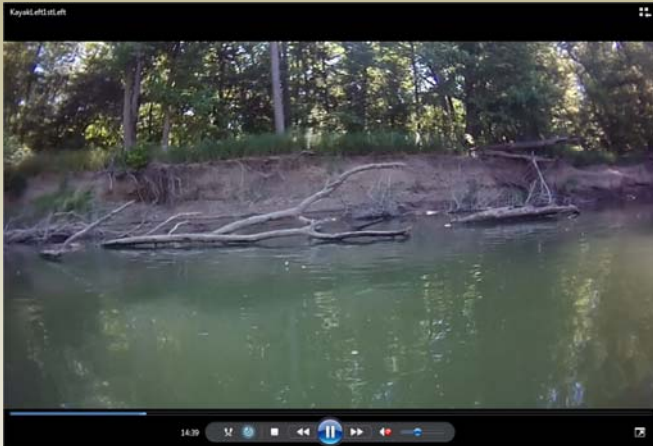
Bank Angle = 6.95, Bank Height = 7.5, Surface Protection = 9, Riparian Diversity = 9  
BESI value = 32.45
